RESEARCH MEMORANDUM

CYCLIC ENGINE TEST OF CAST VITALLIUM TURBINE BUCKETS - I

By J. Elmo Farmer, F. N. Darmara
and Francis D. Poulson

February 19, 1948

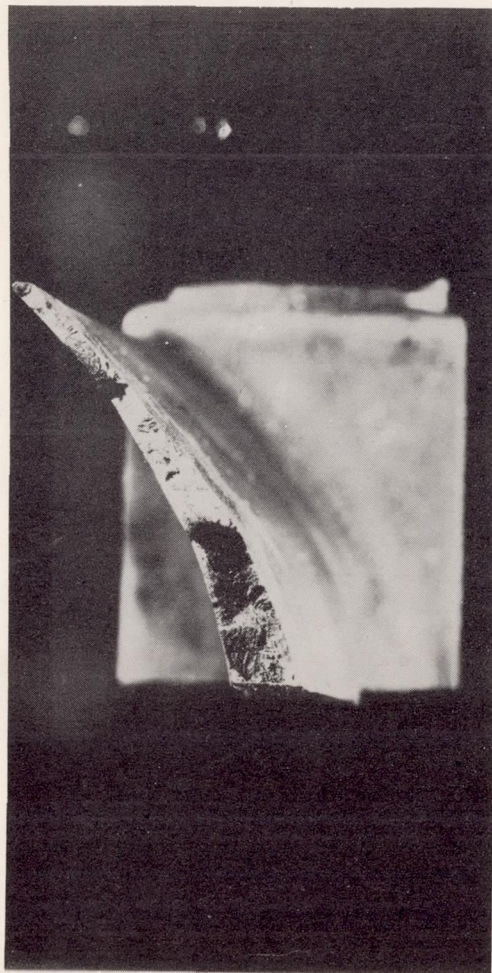
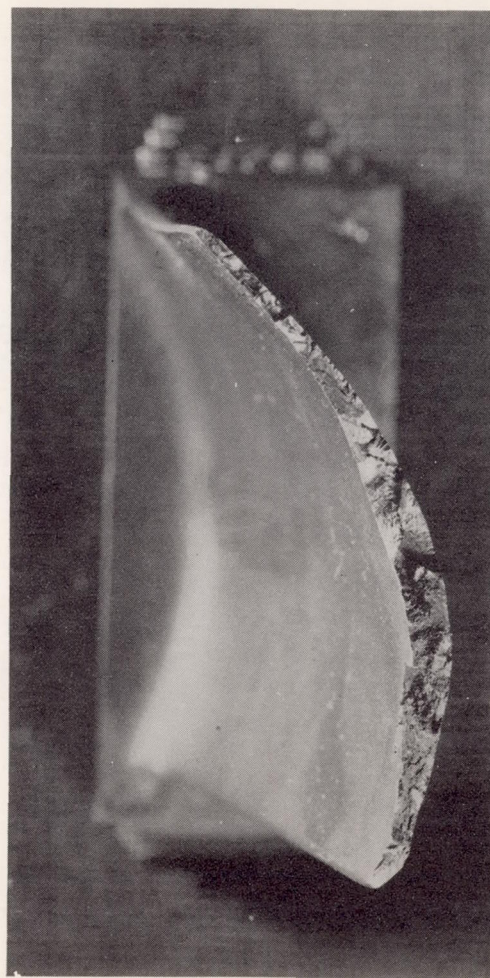
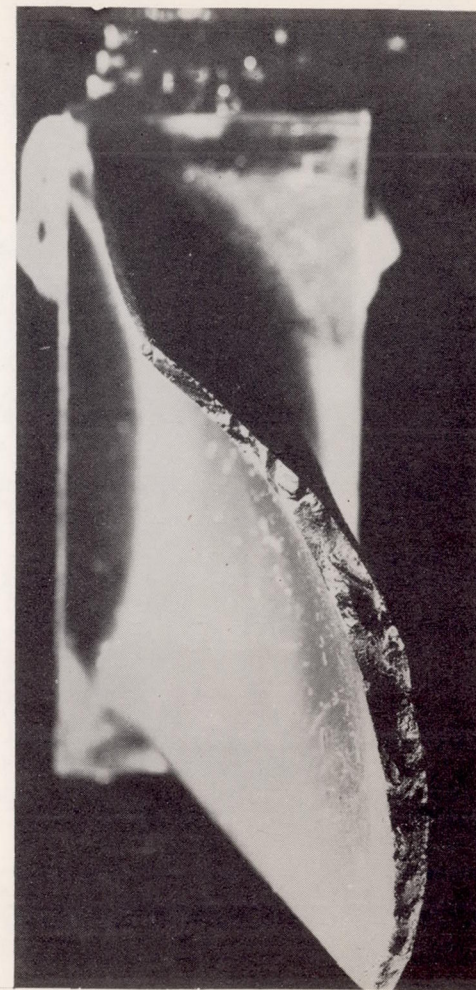
The macroexamination did not disclose any significant differences either between the three samples or between broken and unbroken buckets from the same wheel. The grains at the trailing edge were much smaller than in the body of the bucket probably due to variation in the cooling rate in the mold. (See fig. 3.)

Figure 3. - End views of broken st Vitallium turbine buckets.

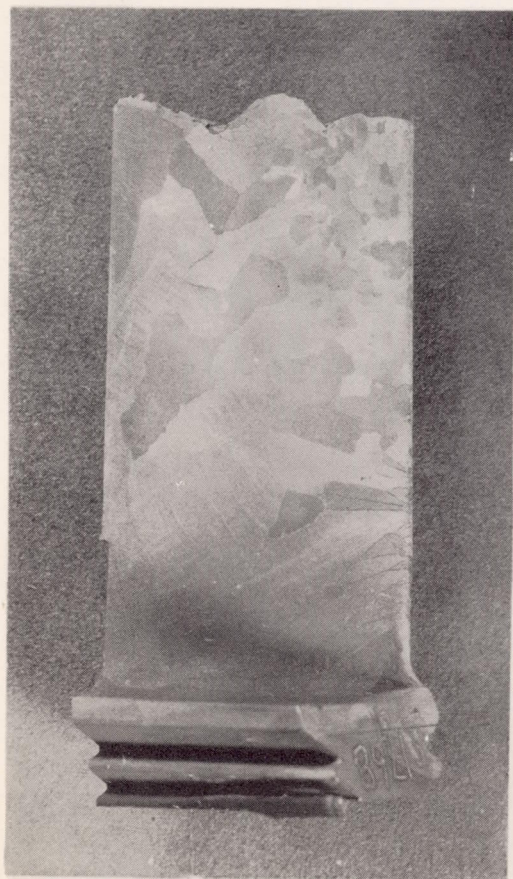
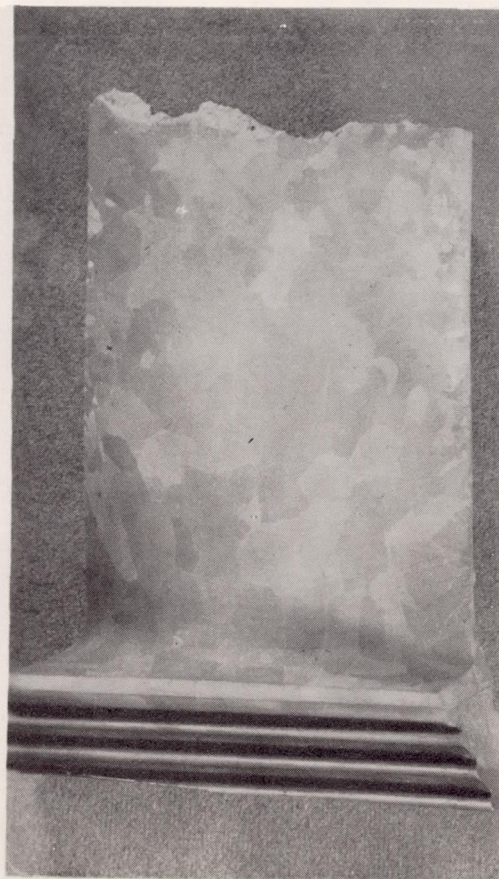
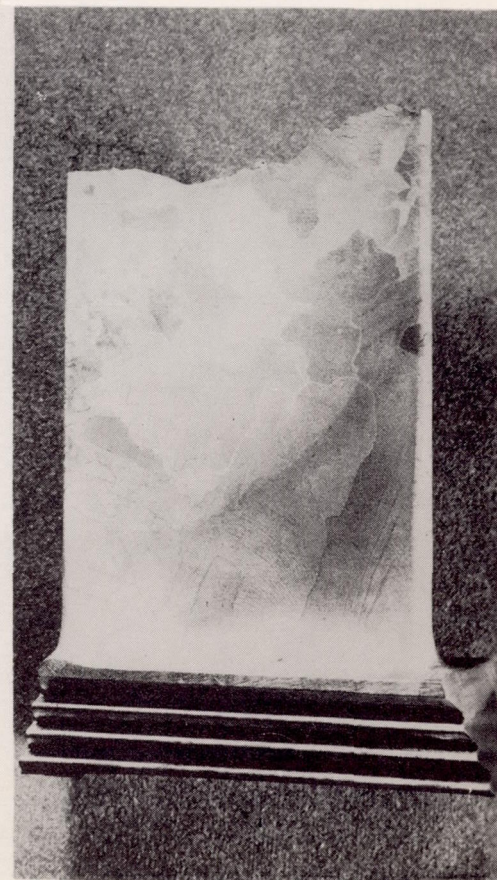
Figure 4. - Side views of broken cast Vitallium turbine buckets. Buckets were electrolytically etched in 10-percent hydrochloric acid to show grain size.

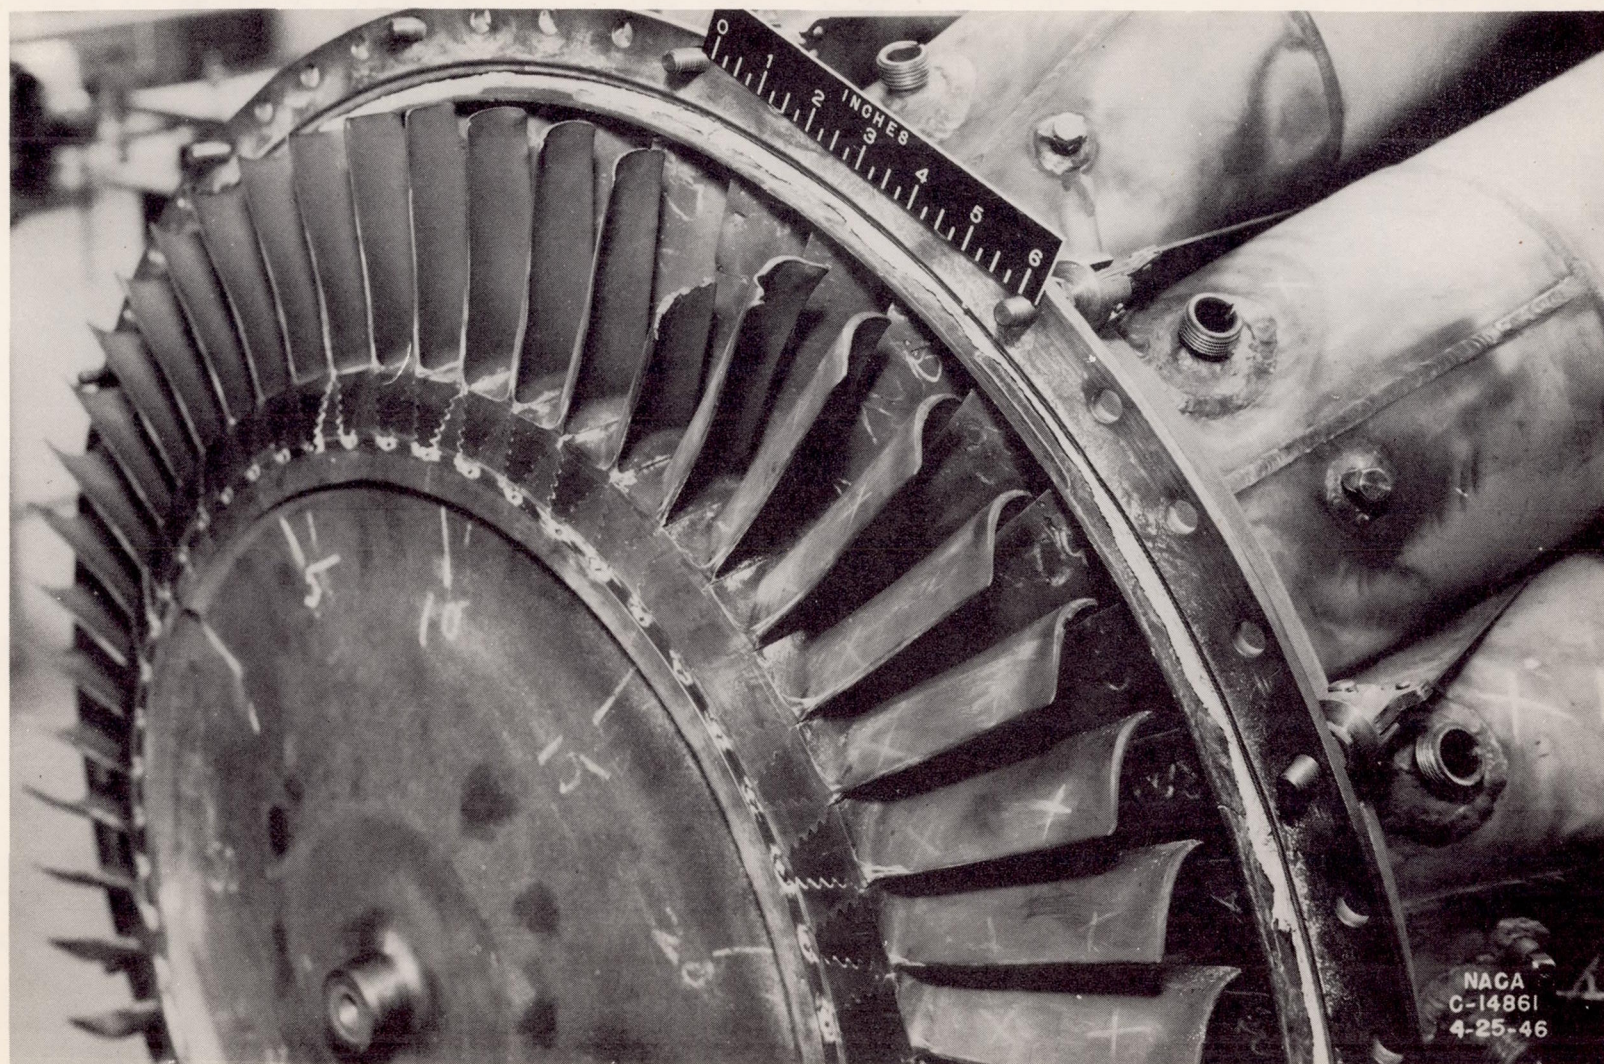
Wheel 1. - Wheel 1 was installed in an engine and was run-in by the engine manufacturer prior to the tests at the Cleveland laboratory. The first failure on wheel 1 occurred during cycle 22 after 7 hours and 20 minutes. The broken bucket (bucket 1-13), shown in figure 6, was replaced, the wheel rebalanced, and the runs

Figure 6. - Wheel 1 after first bucket failure (bucket 1-13), which occurred during cycle 22 (7 hr, 20 min).

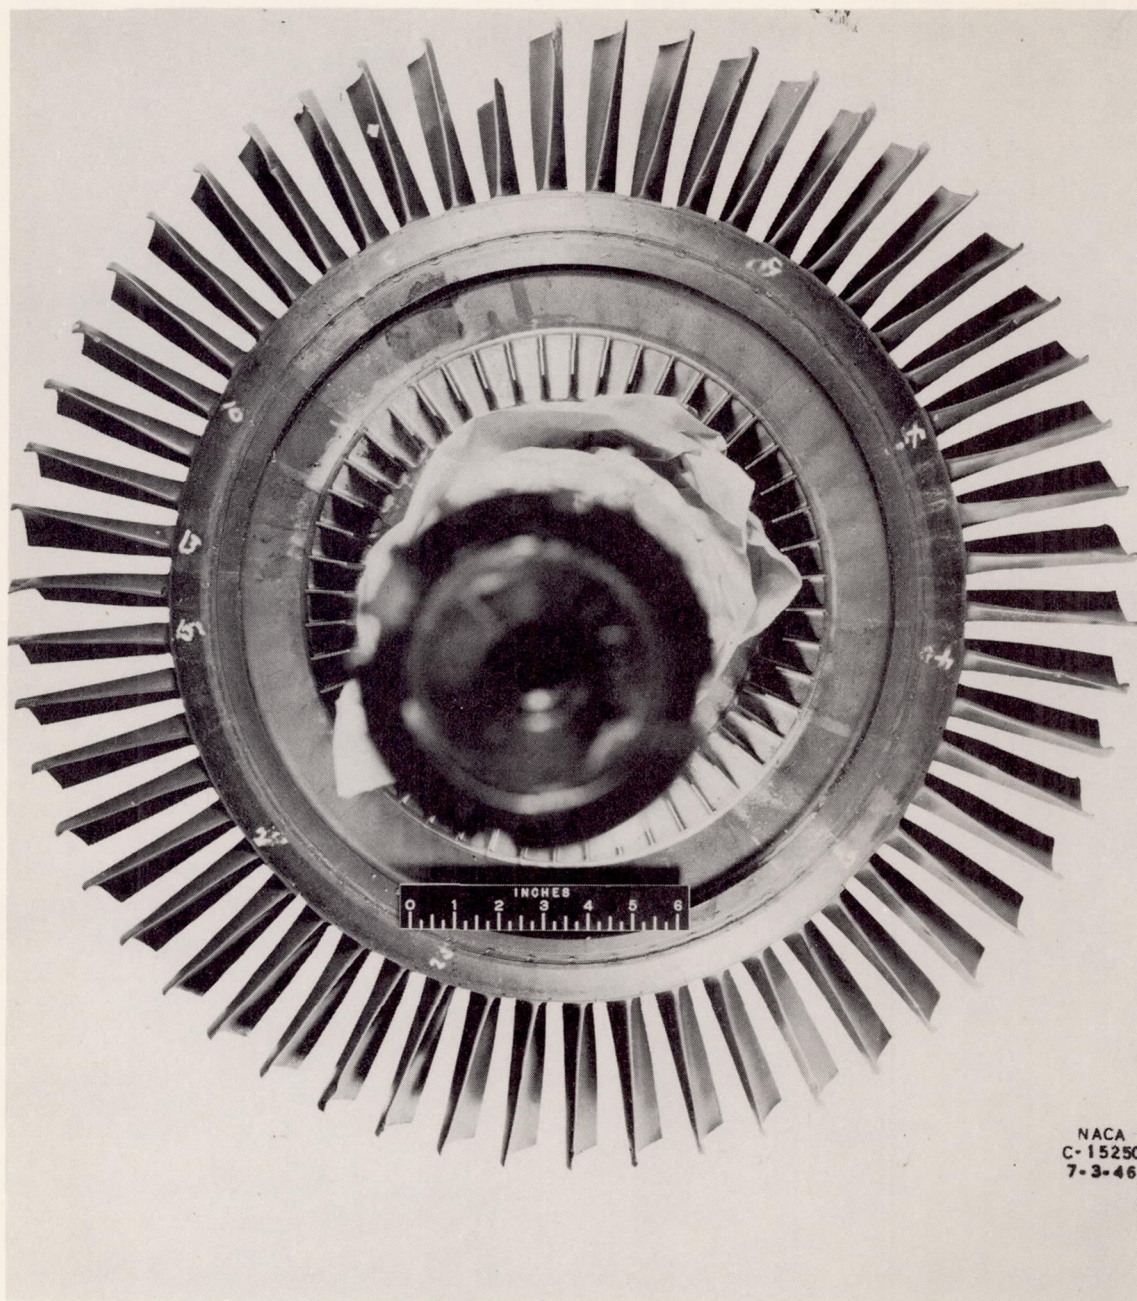
continued. Bucket 1-2 failed three cycles later during cycle 25 after a total running time of 8 hours and 12 minutes (fig. 7). Buckets 1-12 and 1-14 were removed for comparison with the broken buckets.

Figure 7. - Wheel 1 after second bucket failure (bucket 1-2) which occurred during cycle 25 (8 hr, 12 min).

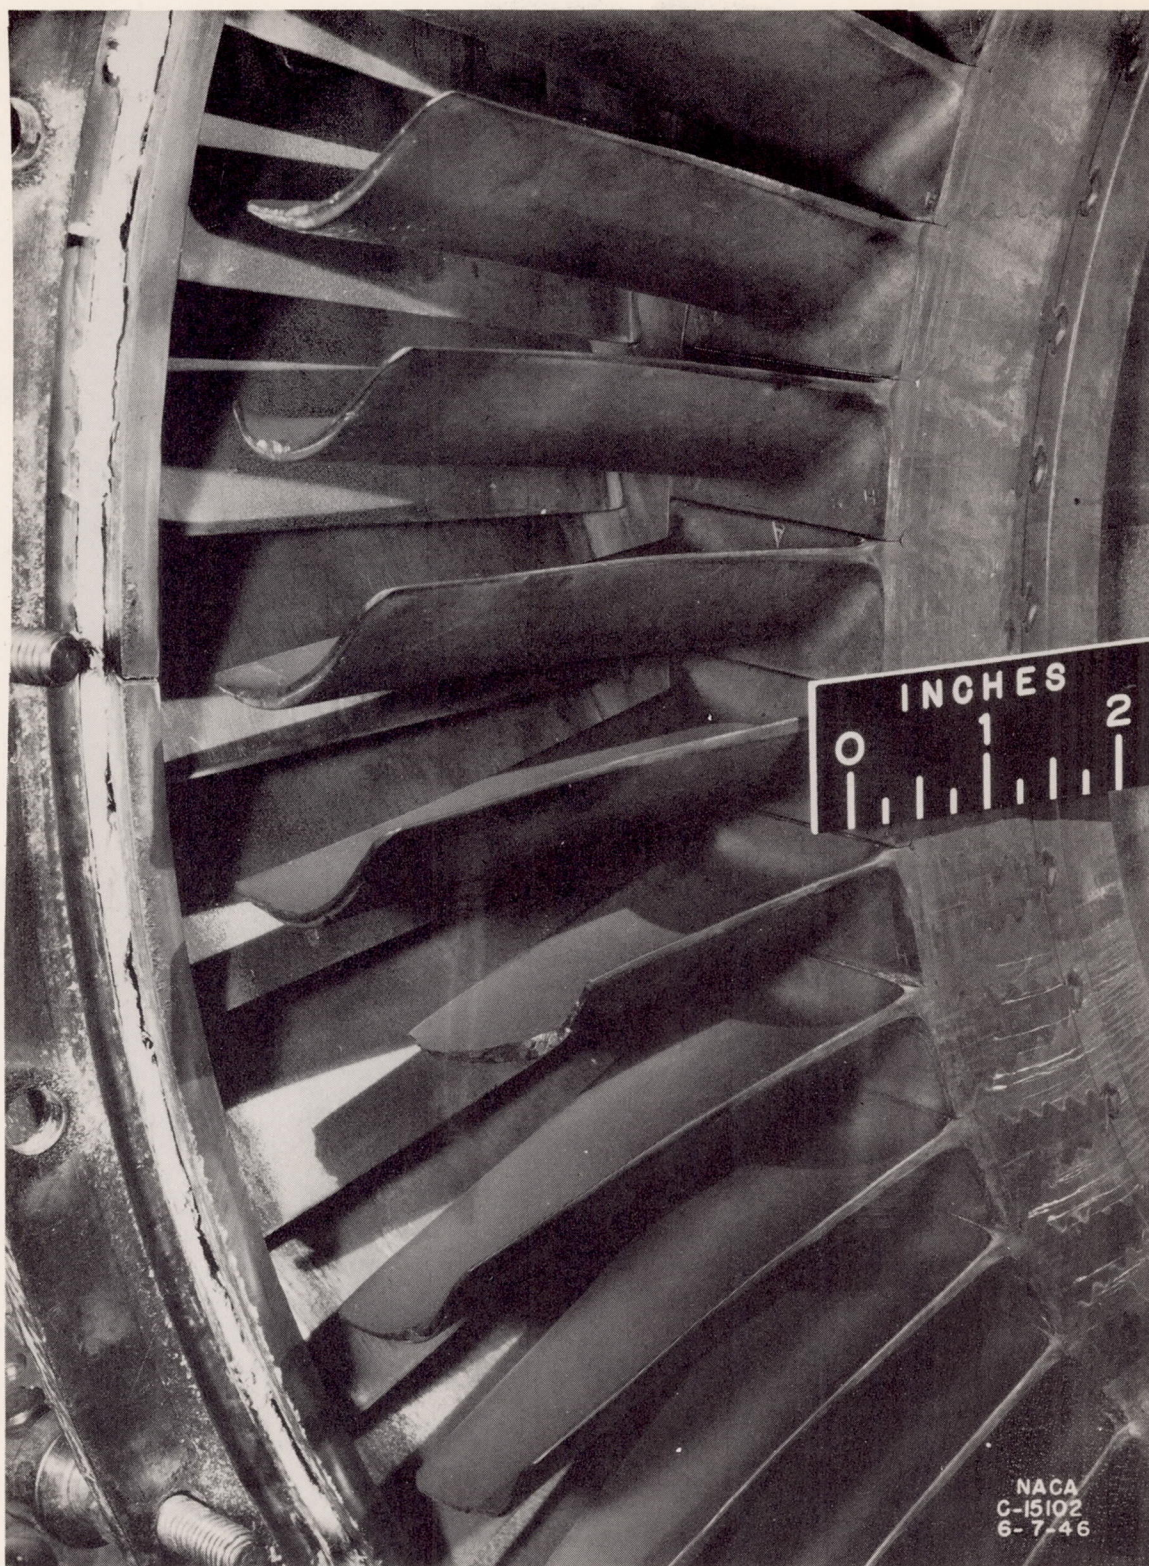
Wheel 2. - Wheel 2 had not been run prior to this investigation. The first bucket failure on wheel 2 (bucket 2-18) occurred in cycle 29 after 9 hours and 28 minutes (fig. 8). The broken bucket was replaced, the wheel rebalanced, and the run continued. After 95 cycles (31 hr, 40 min total running time), the test was stopped to repair the rear-compressor-inlet guide vanes and the ring-and-tube assembly.

Figure 8. - Wheel 2 after first bucket failure (bucket 2-18), which occurred during cycle 29 (9 hr, 28 min).

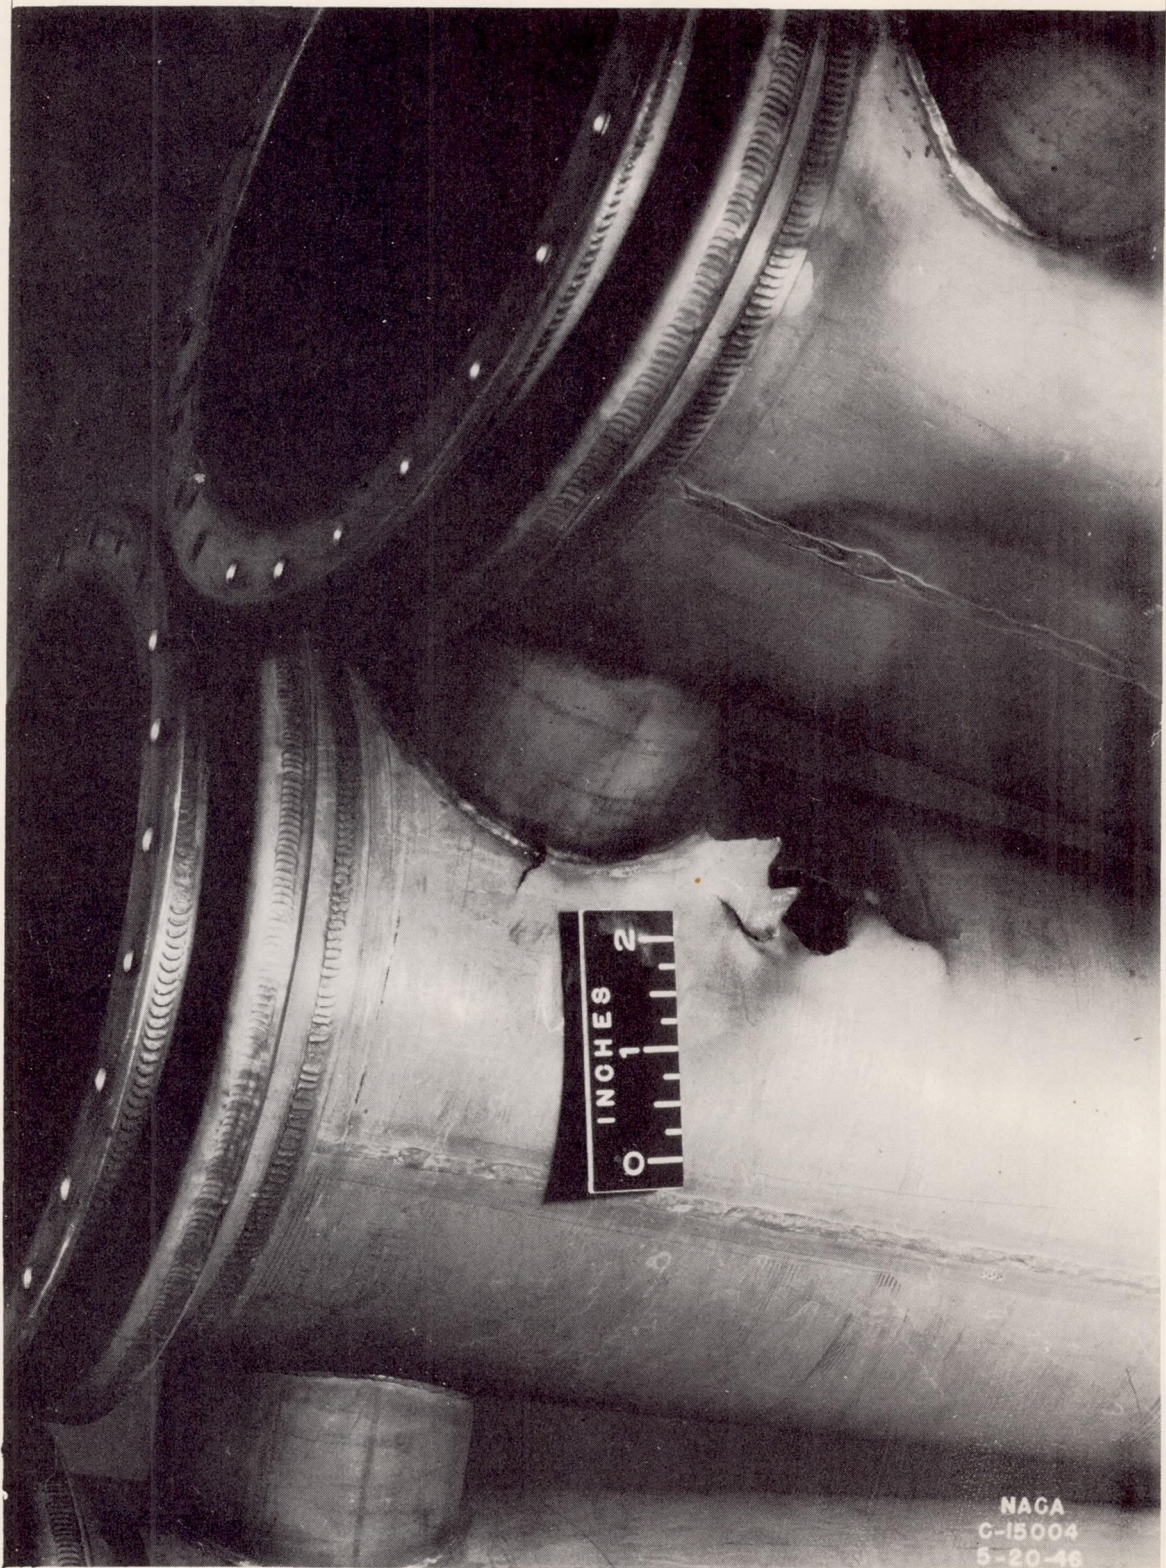
After 11 hours and 8 minutes, the ring-and-tube assembly was found to be so badly damaged that the engine could not be run. The damage sustained by one of the outer flame tubes is shown in figure 9. Operation was resumed after the ring-and-tube assembly had been replaced. An inspection after a total running time of 28 hours and 44 minutes showed that the nozzle diaphragm had been badly eroded (fig. 10) and that the stiffeners on the compressor cover plate were cracked.

Figure 9. - Damaged outer burner tube after 11 hours and 8 minutes.

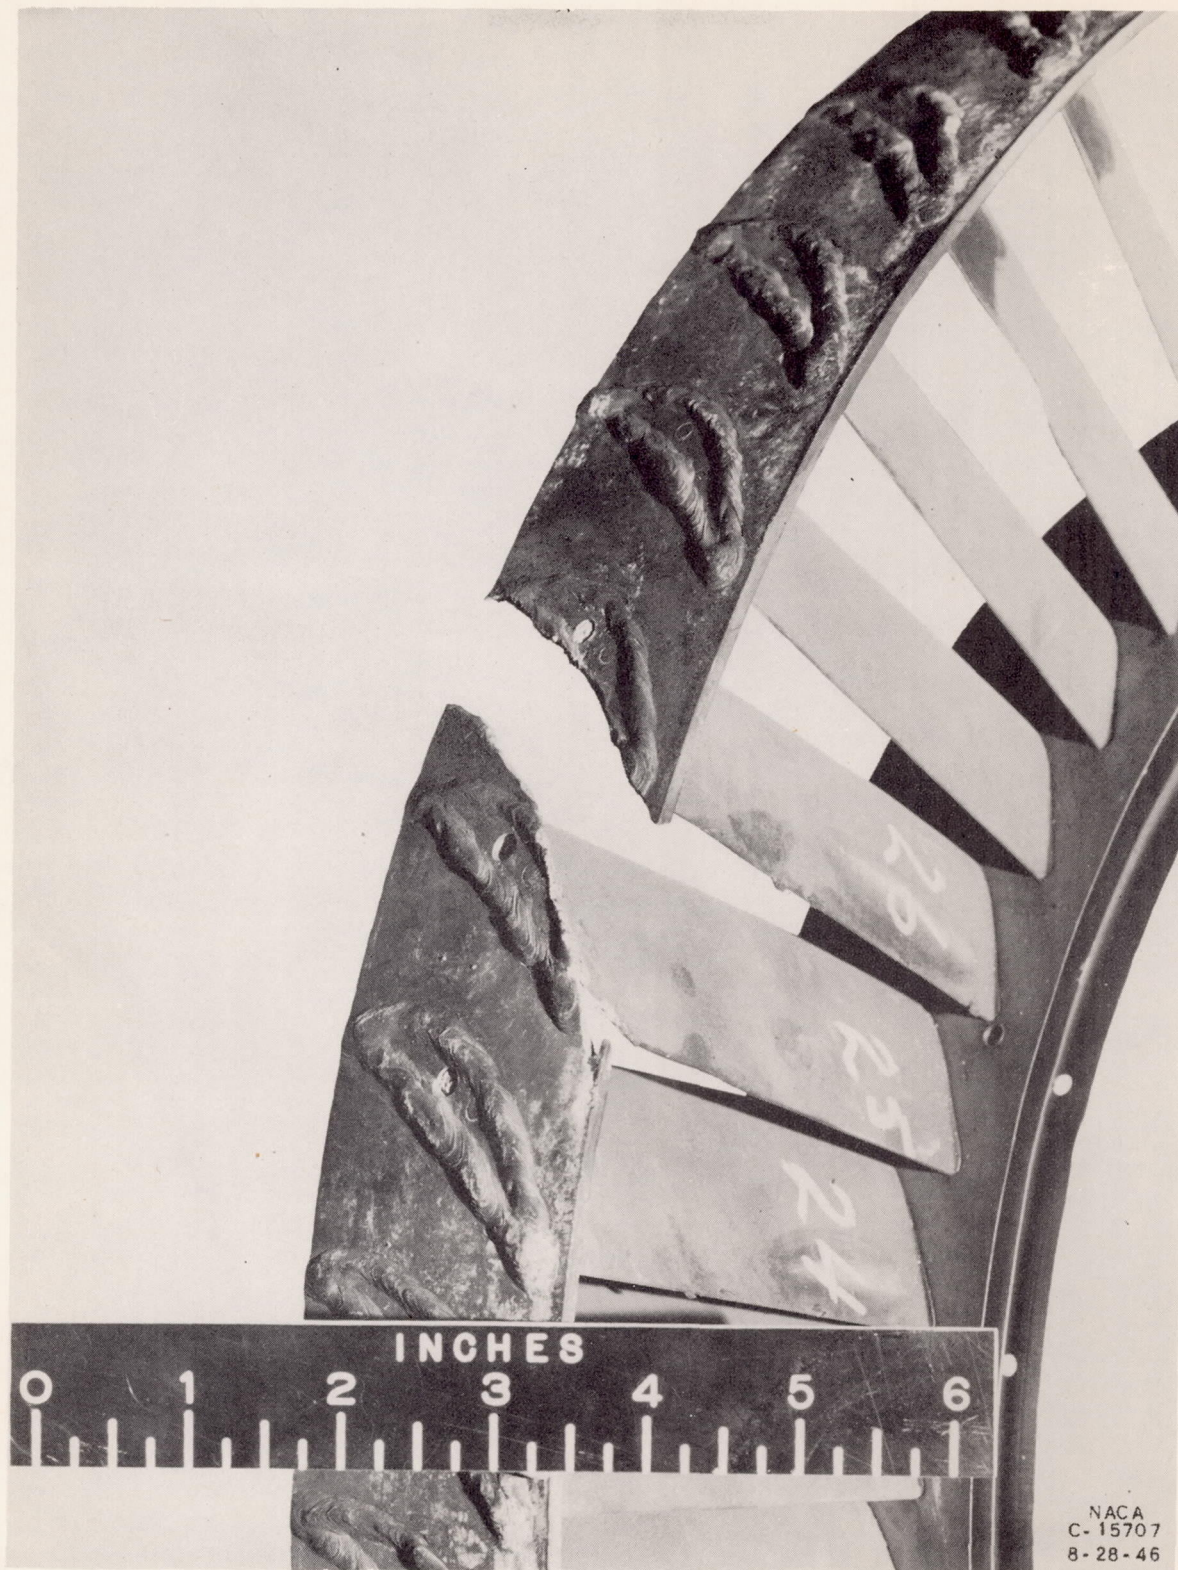
Figure 10. - Damaged turbine-nozzle diaphragm from engine after 28 hours and 44 minutes.

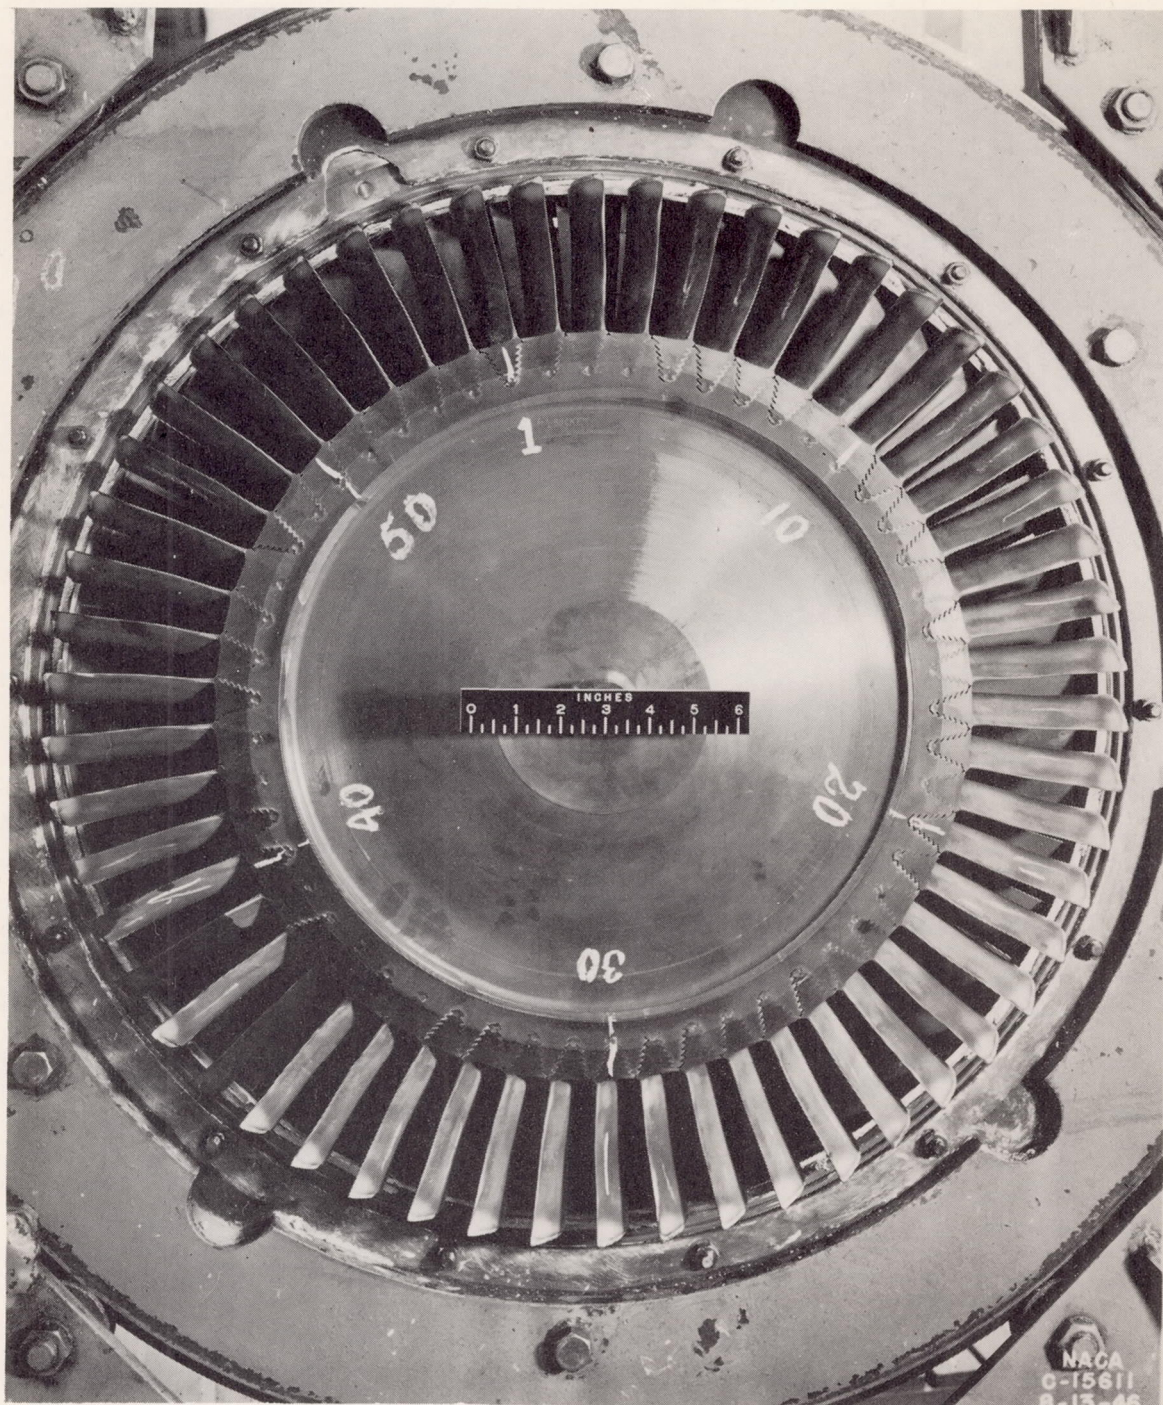
The turbine wheel was therefore removed, installed in another engine, and the running resumed. After cycle 229 (76 hr, 20 min total running time), the nozzle diaphragm was again found to be in bad condition and the engine was removed from the test cell for overhaul. No bucket failure had occurred. Many of the buckets had shifted in the axial direction, six of them sufficiently to rub on the gas baffle in the exhaust cone (fig. 11). Two buckets (buckets 3-16 and 3-43) were removed from wheel 3 for comparison with the broken buckets from the other wheels.

Figure 11. - Wheel 3 after a total running time of 76 hours and 20 minutes showing axial shift of buckets.

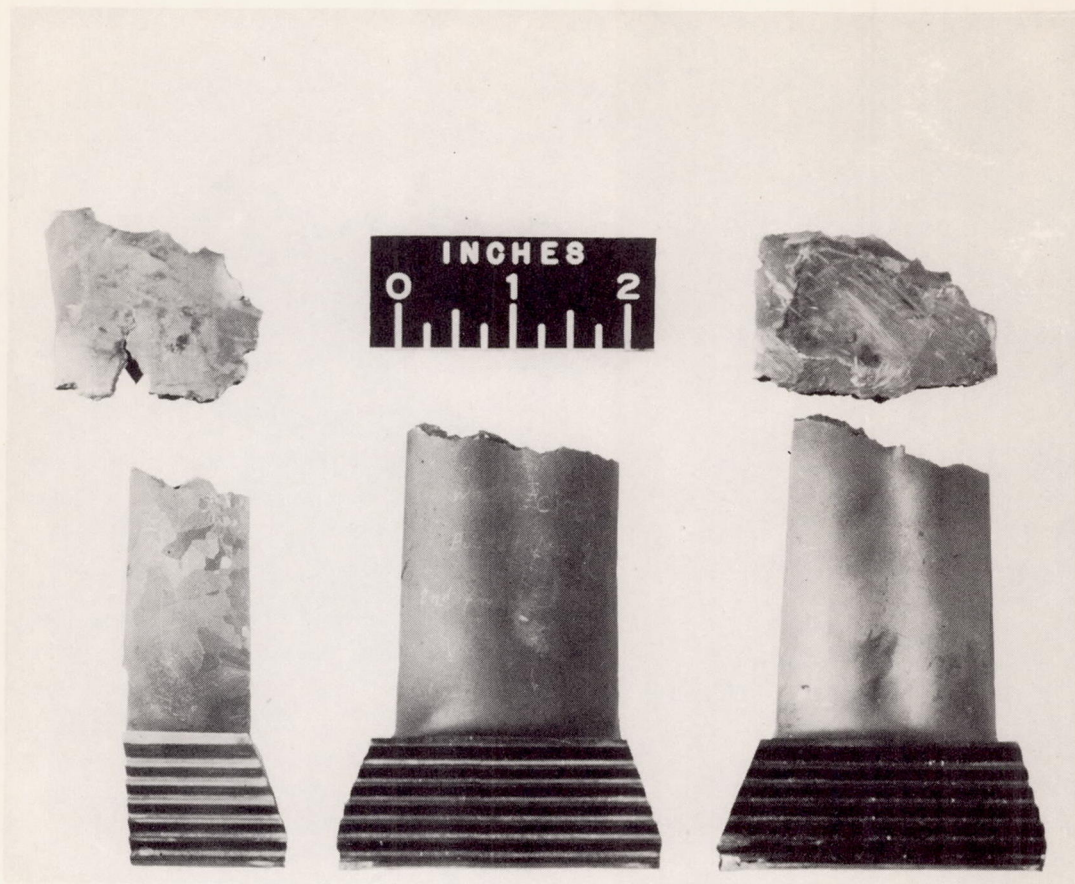
1. The appearance of the failure is the same in all samples.
2. The fracture exhibits two definite zones, which are quite different in appearance. From the trailing edge to about the middle of the bucket, the fracture has a conchoidal surface similar to those of fractures obtained in the failure of brittle materials. This part of the fracture is referred to as the "brittle" fracture. The brittle fracture has a dark gray coat of oxide. The rest of the crack has a fibrous appearance very similar to that exhibited by tensile-test specimens that have failed with a cup-and-cone fracture. This portion of the fracture is referred to as the "ductile" fracture. The ductile fracture has a bright blue oxide coating.

These observations lead to the conclusion that the failures are due to fatigue cracks that start at the trailing edge and progress until the centrifugal-force stress on the remaining portion of the blade becomes equal to the ultimate strength and the material fails in tension. Specimens that have failed in stress-rupture tests of long duration (that is, of low stress) exhibit this type of brittle failure; however, the cracks present in such failures are intercrystalline and not transcrystalline.

Figure 13. - Broken cast Vitallium turbine buckets. Bucket 1-13 was sectioned for metallographic examination.

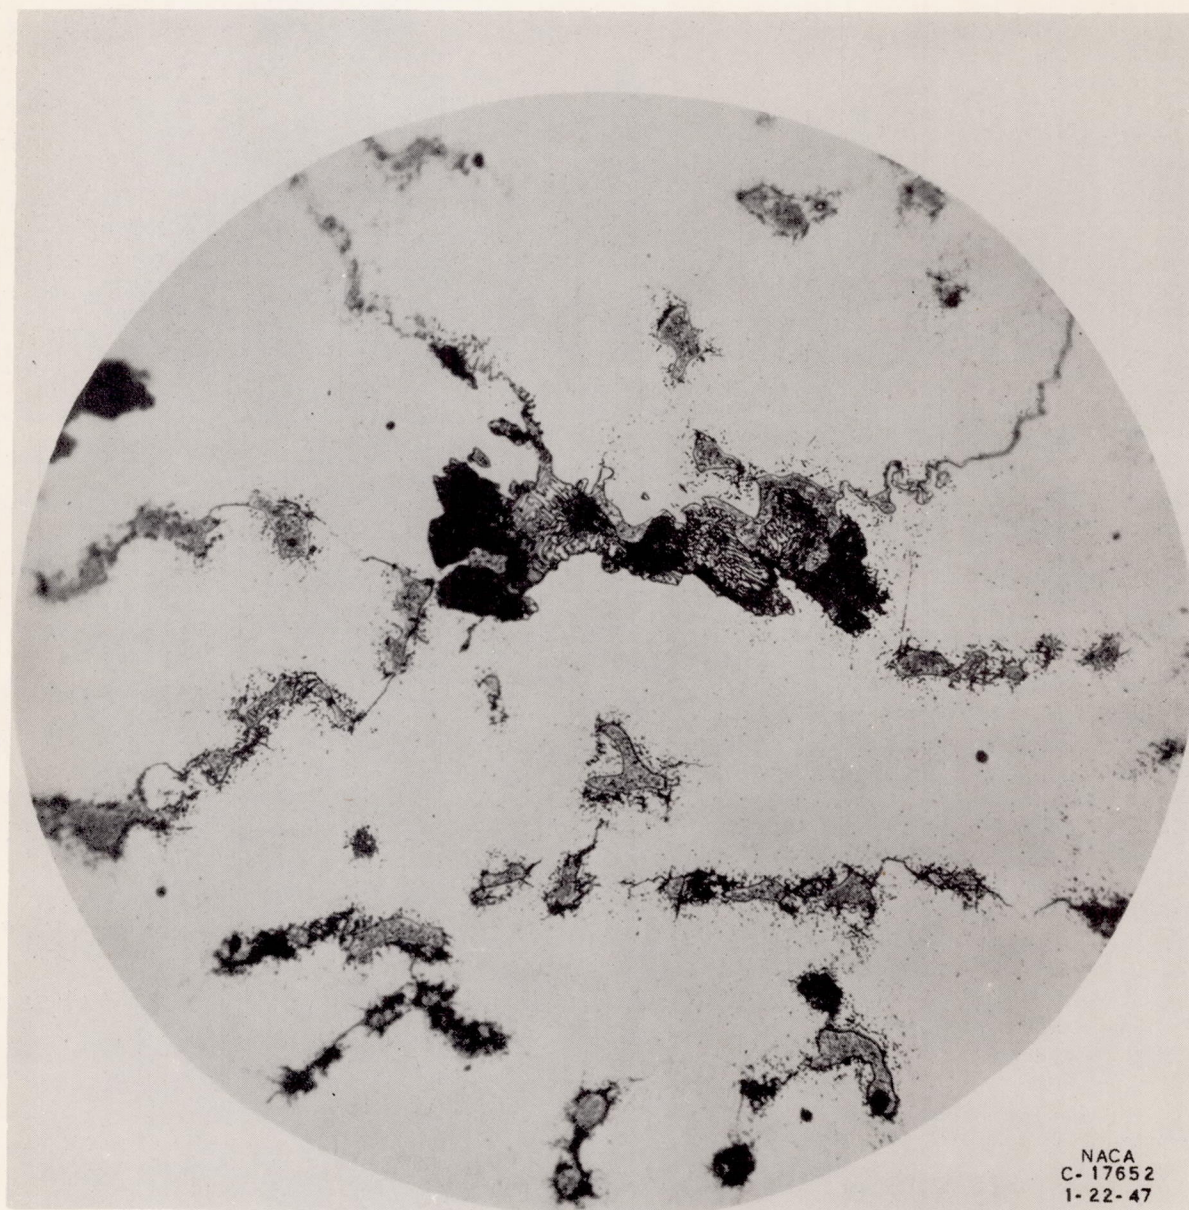
Microscopic investigation did not definitely establish the cause of the bucket failures. Well-defined eutectic areas at the dendritic boundaries and some carbide precipitation existed (fig. 15). These eutectic areas (figs. 16 and 17) are very prominent at the trailing edge, where it is believed the crack started. A view of a comparable area at the leading edge (fig. 18) shows a small amount of eutectic material. Such a concentration of eutectic areas at the trailing edges may be a factor contributing to the start of fatigue cracks.

Figure 15. - Microphotograph of sample from location 3 (fig. 5) one-half inch from crack showing eutectic area and precipitated carbides. Aqua-regia etch, 5 percent; magnification, 500X.

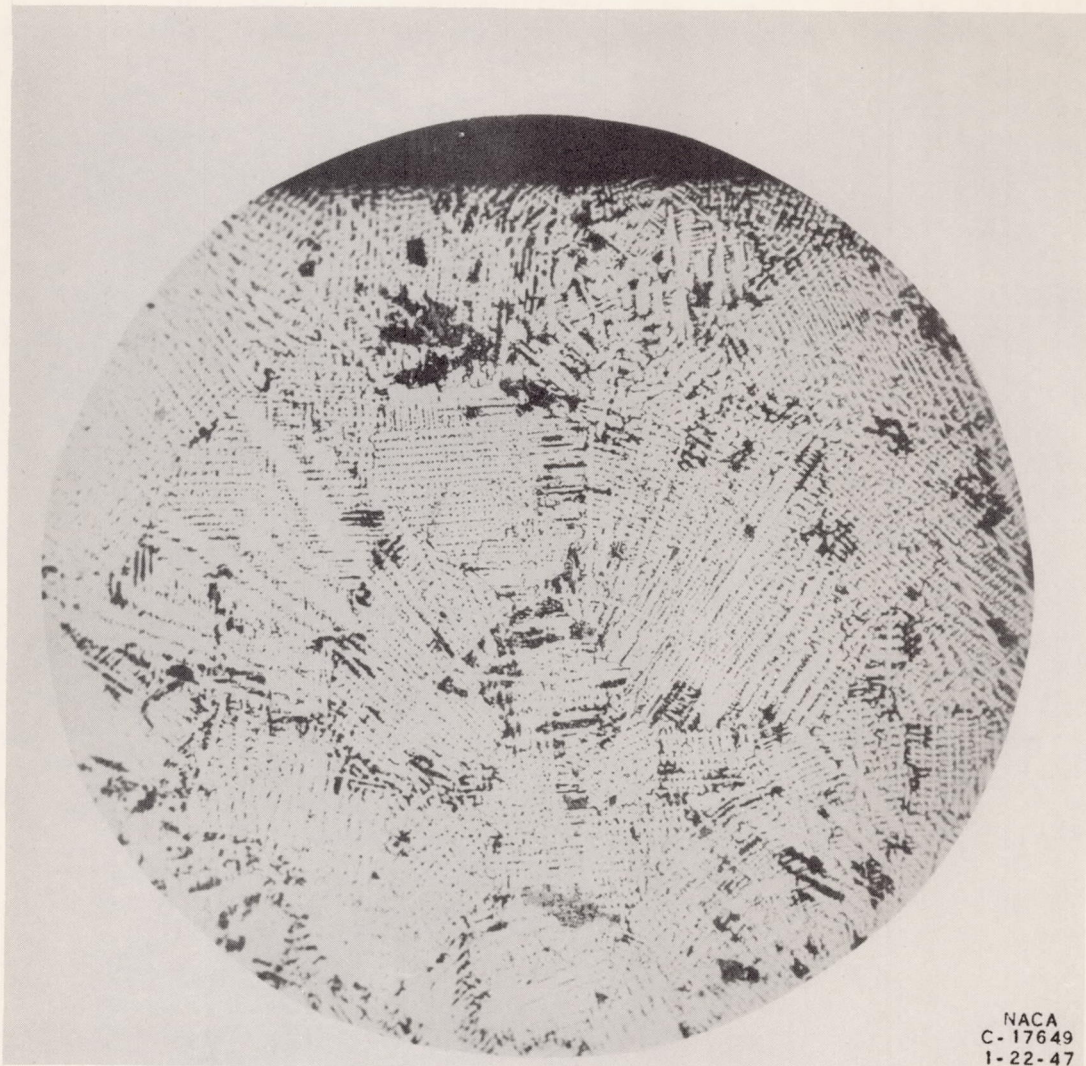
Figure 16. - Microphotograph of sample from location 1 (fig. 5) close to brittle portion of crack showing large amounts of eutectic material at grain boundaries. Chromic-acid and potassium-permanganate etch; magnification, 50X.

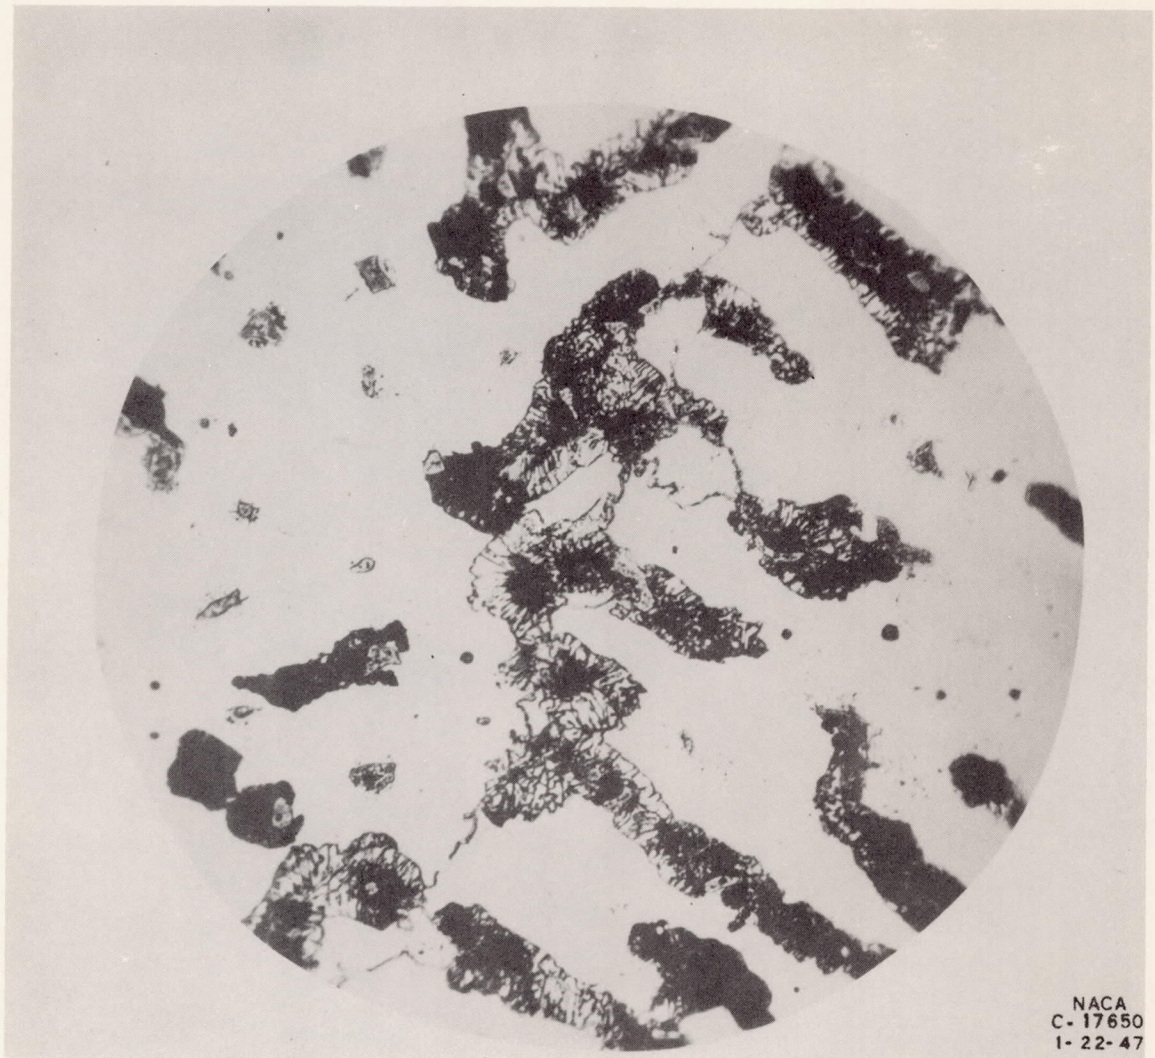
Figure 17. - Microphotograph of sample from location 2 (fig. 5) close to brittle portion of crack showing large amounts of eutectic material at grain boundaries. Aqua-regia etch, 5 percent; magnification, 500X.

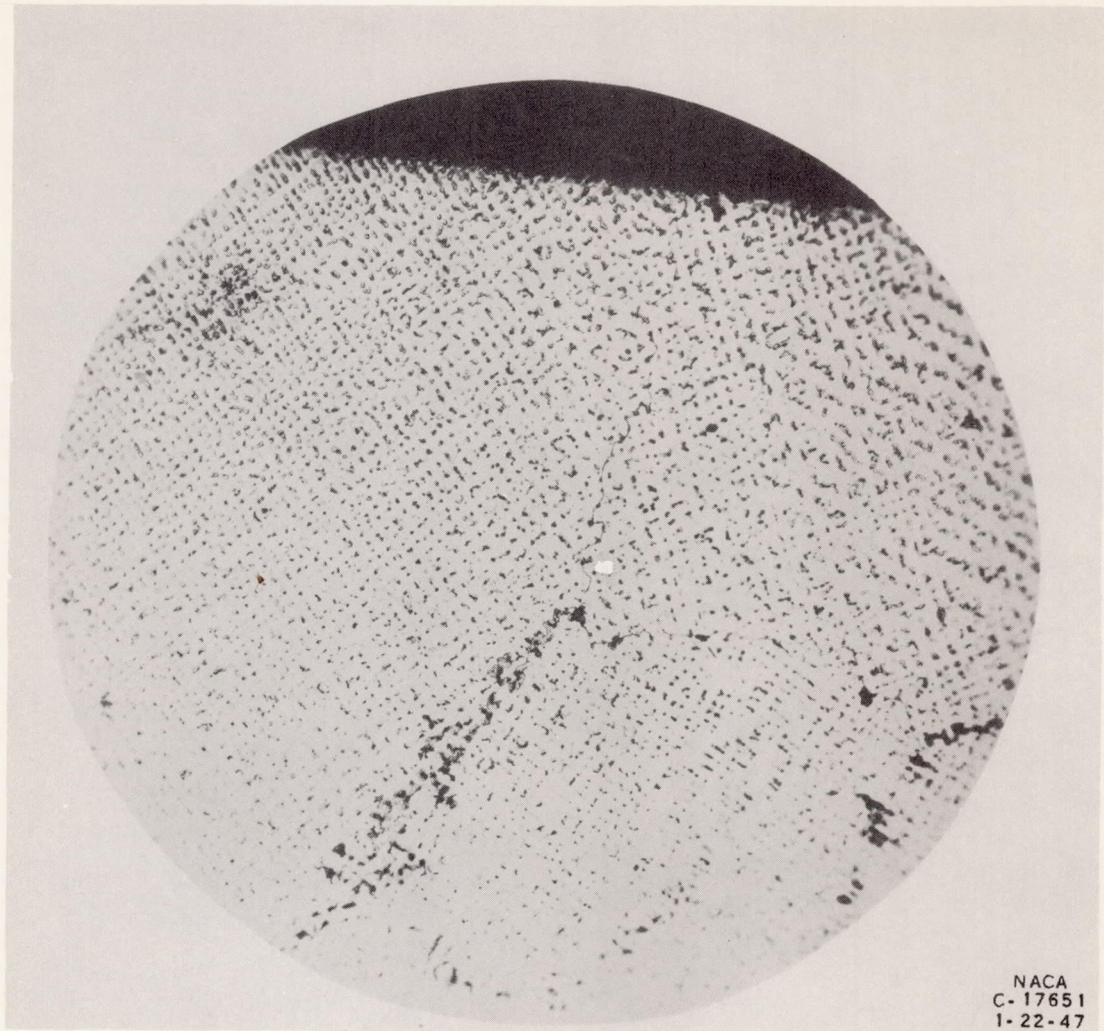
Figure 18. - Microphotograph of sample from location 4 (fig. 5) at leading edge showing very little amount of eutectic material. Chromic-acid and potassium-permanganate etch; magnification, 50X.
